TCS-80248/65  
February 1965

PHOTOGRAPHIC INTERPRETATION REPORT

# HSIANG-HSIANG EXPLOSIVES COMPLEX CHINA

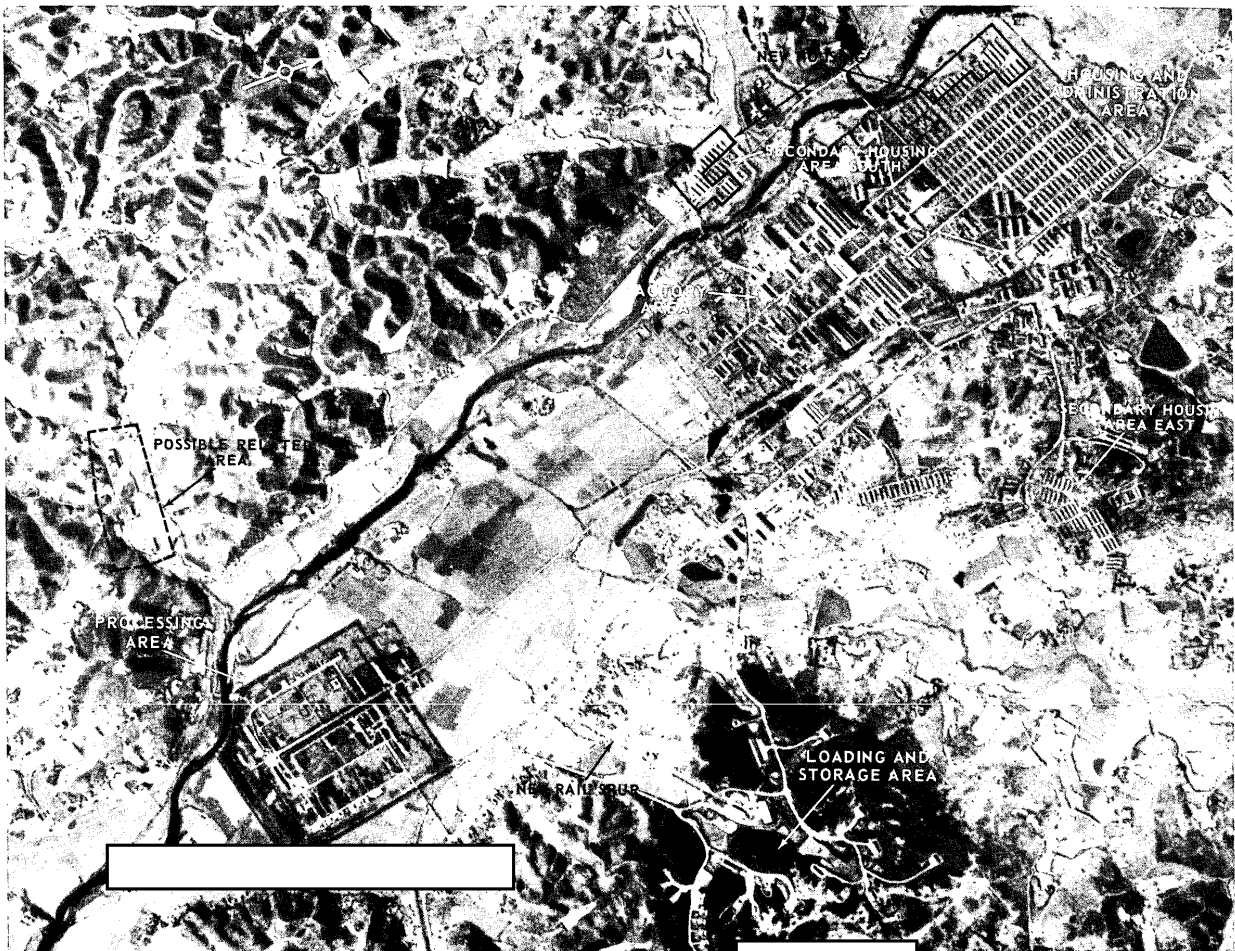
FIGURE 2. HSIANG-HSIANG EXPLOSIVES COMPLE

Construction has continued throughout the complex (Figure 2). The most significant additions have been in the Loading and Storage Area where a new rail spur, an associated new transloading building, and 8 explosives storage buildings served by individual roads have been added since the [REDACTED] coverage. In the Factory Area a building under construction in [REDACTED] has been completed, 7 new buildings have been added, and another is under construction. The Processing Area, the most highly secured in the complex, has had the least amount of new construction; 2 support/

storage buildings were added, 2 buildings were revetted, and the inner security wall was extended. Approximately 25 new single-story multifamily structures have been added in 2 of the housing areas. No significant changes have been observed since [ ] in the section designated Possibly Related Area.

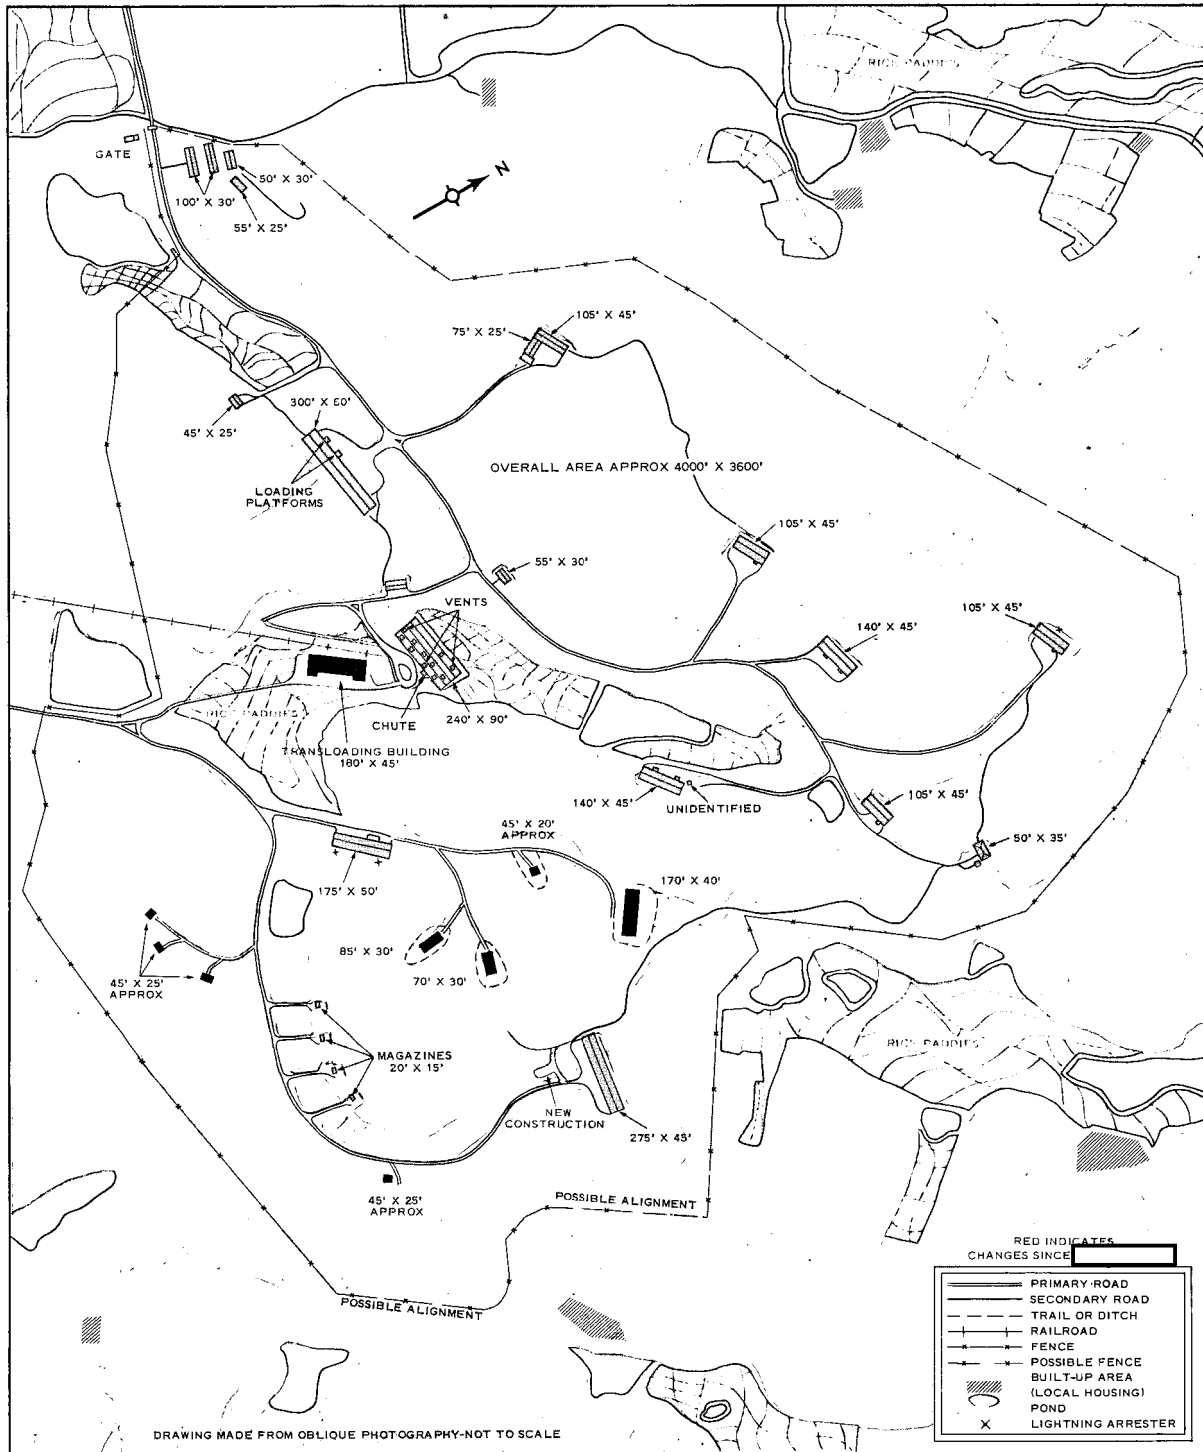
FIGURE 5. LOADING AND STORAGE AREA.

The storage capacity of the Loading and Storage Area, which is situated in hills north-east of the Processing Area, has been increased significantly since [REDACTED] (Figure 5). There have not been any changes in the area security provisions.

A new transloading building measuring 180 by 45 feet was built near the southern entrance to the area, and a new rail spur was constructed to the building. Both the building and the rail

spur were added to the area between [REDACTED] [REDACTED] during the same period a new road was constructed around the transloading building.

Eight new explosives storage buildings of various sizes have been added to the area since [REDACTED]. These buildings, which are individually served by new roads, are located in small valleys; this terrain provides good blast protection. Five of the buildings were constructed between [REDACTED] 1 between [REDACTED] and 2 between [REDACTED]. The last 2 were probably still under construction, but the small scale of the photography limits interpretation of details. The 3 larger buildings and the smaller building nearest to them are circled by narrow trails or ditches.

New construction began after photography of [REDACTED] at a location in the eastern section of the area. This new construction consists of a rectangular scarred area and road construction. The road pattern indicates that additional storage buildings will probably be built in this area.
